Suture Anchors and Tacks for Shoulder Surgery, Part II

The Prevention and Treatment of Complications

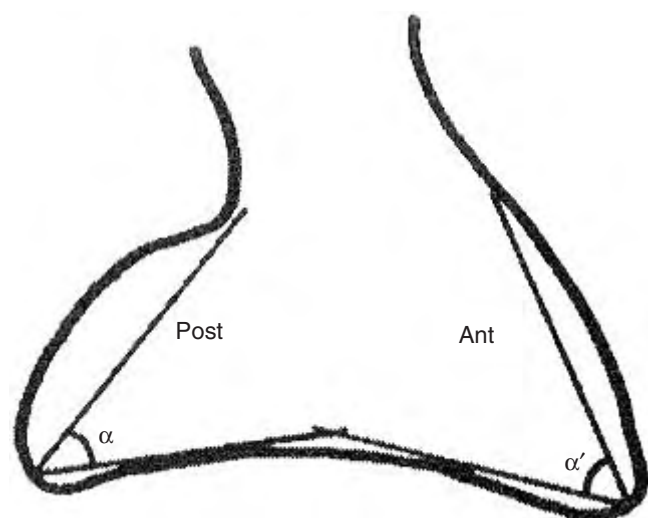
Figure 1. The glenoid rim angle, as seen in a cross-section of the glenoid, is a measure of how much bone is available for insertion of a suture anchor or tack. (Reprinted from *Arthroscopy*, 20, Lehtinen JT, Tingart MJ, Apreleva M, et al, Variations in glenoid rim anatomy: implications regarding anchor insertion, 175-178, 2004, with permission from The Arthroscopy Association of North America.)

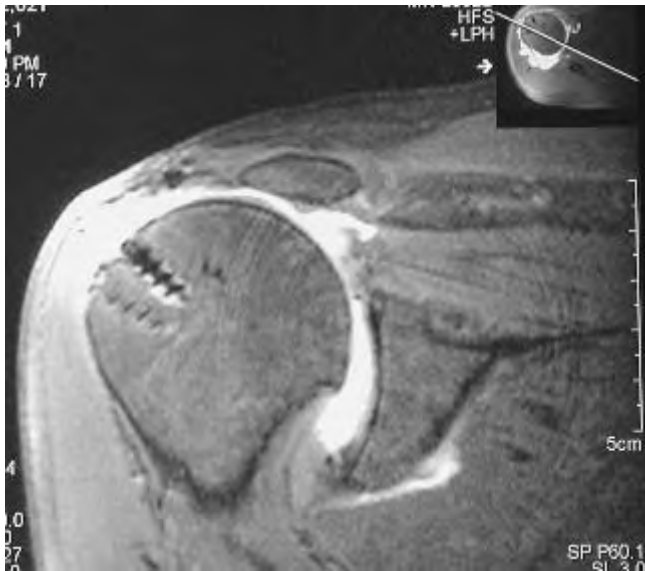
Figure 5. Magnetic resonance image (oblique coronal view) of suture anchors with osteolysis around the anchors. The patient had severe synovitis and 1 anchor floating in the joint.

Osteolysis of the bone surrounding both absorbable and nonabsorbable implants has been described for implants used for fracture management and also for implants in the knee (eg, interference screws) and shoulder (eg, suture anchors).^{1-3,6,15,27,57} The exact cause of the tunnel-widening seen on radiographs is not known entirely, but in some instances, it has been associated with a foreign-body reaction and loosening of the implant^{6,21} (Figure 5).

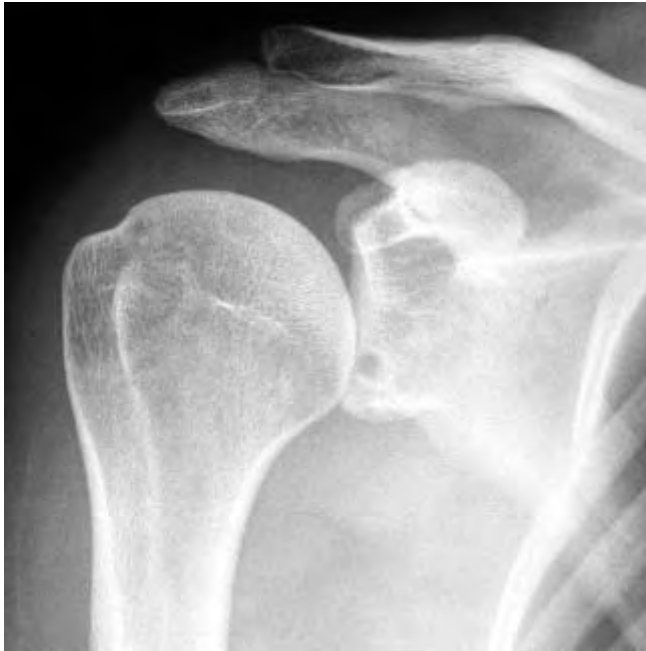
Figure 6. Plain anteroposterior radiograph of a shoulder with osteolysis around absorbable anchors. This patient had a successful result with no recurrence of instability.

The most extensive studies of this issue have been performed by Ejerhed et al^{15,16} and Kartus et al.²⁷ Those authors^{15,16,27} radiographically evaluated and compared the results of patients who underwent open anterior shoulder stabilization with absorbable TAG anchors (Acufex Microsurgical Inc) with those of a similar cohort who had Suretac tack fixation (Acufex Microsurgical Inc).²⁷ At a minimum of 18 months' follow-up, there were visible drill holes or cystic areas around the anchors in 56% of those with TAG anchors and in 23% of those with Suretac devices. However, these findings could not be associated with clinical result.²⁷ Similar findings were obtained when they compared the results of absorbable and nonabsorbable suture anchors for the open repair of posttraumatic anterior instability in 33 patients.¹⁶ The incidence of visible holes or cystic changes was 60% in those with absorbable anchors and 66% in those with nonabsorbable anchors. There was no relationship between these lucencies and the final clinical outcome¹⁶ (Figure 6).

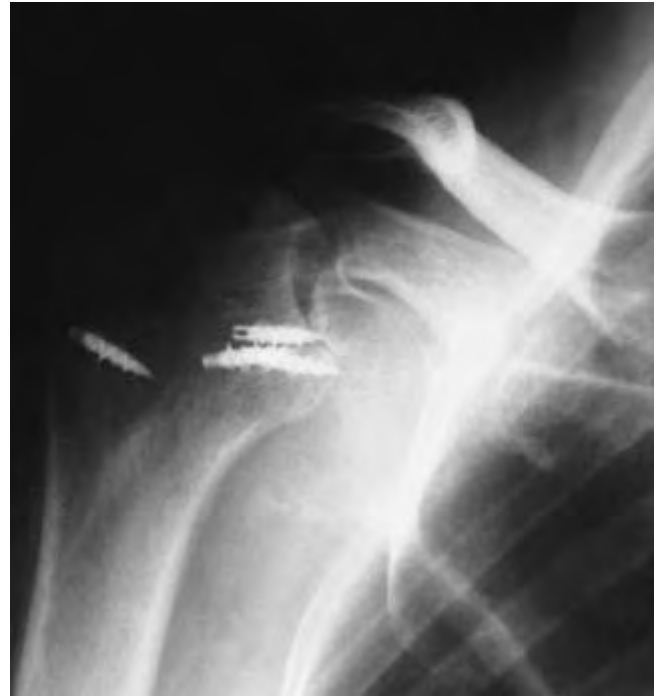
Figure 7. Plain anteroposterior radiograph of the shoulder of a patient with suture anchors placed deep in the humeral head.

Deep implantation of suture anchors in the humeral head also may compromise the blood supply of the humeral head in rare instances (Figure 7). Deep implantation has been shown to shift the mode of failure of suture anchors from abrasive wear of the suture at the eyelet to suture cutting through the bone.⁹ In some systems for inserting anchors and tacks, the depth of penetration is not well controlled, especially in osteoporotic bone. In our practice, 2 patients with deeply inserted anchors developed bone collapse and pain. Although the exact cause of bone collapse in these patients is speculative, we believe deep insertion of the anchors may have contributed. It is recommended that patients with increasing pain and loss of motion after the use of suture anchors or tacks have plain radiographs and, if necessary, MRI to evaluate for this complication.
